SUNGROW

MC4 Melted Plugs

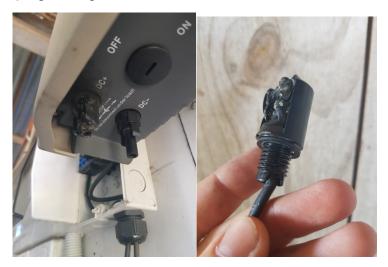
In the cases where an installer reports a melted plug(s), it is almost always due to either of two reasons:

- 1. Incompatible plug types used (not the ones supplied)
- 2. Faulty termination of DC cable.

When the connection is not secure, there is a resistance across the connection, which causes heat. As DC power is constant, the heat builds up and will cause the connection to oxidise even more, causing more resistance. Eventually the heat builds up and melts the plug casing. In rare cases, it can catch fire.

Example of a melted plug

AS/NZS 5033 states that the DC plug and socket must be of the same manufacturer and type. If different brand plugs and sockets are used, the connection may not be properly bonded. Or, that the inner sleeve may push back into the plug body and not connect properly.

In the case of faulty workmanship, the plug insert may not be properly crimped or terminated to the cable.

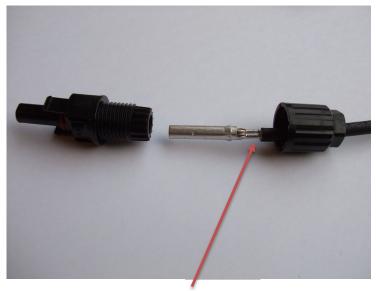
Below is a correctly crimped termination. Note, the correct tool must be used.

Must be solid and tight

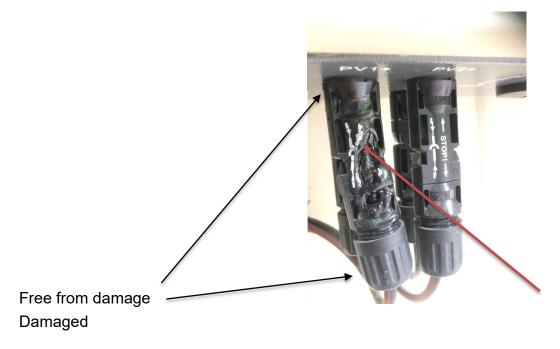
The giveaway is that the damage will be concentrated at the point of maximum heat.

In the below example, we can clearly see that the areas just above and below are not heat damaged. So, the heat is exactly where the connection is.
